# Appendix I. Ground Contamination Review

Te Tai Tokerau Water Trust  
Whangarei

14 September 2020

## Aratapu Water Storage Reservoir, Kaipara – Ground Contamination Review

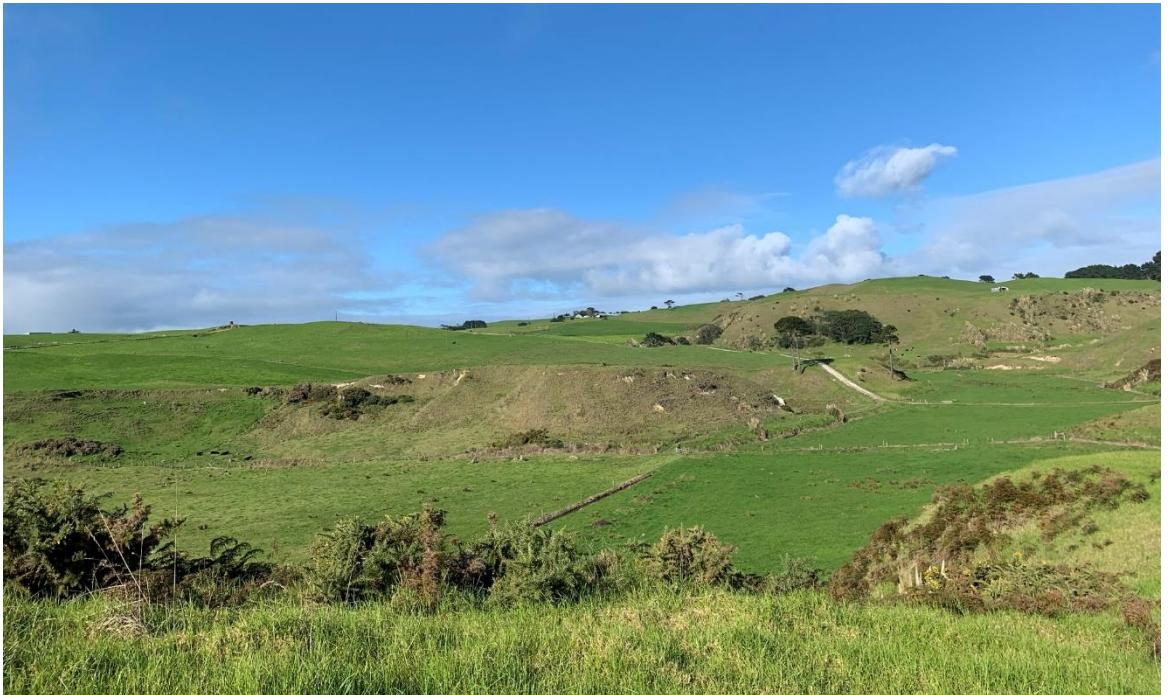
Photograph 1. Current features within the reservoir footprint.

The site walkover confirmed the most recent aerial imagery review (Google Earth, 2020) with fencing, isolated farm sheds (of steel and wood construction) present in the east, and farm tracks, metalled with sandstone, which run through the site. Man-made drainage trenches were also noted, predominantly along fence lines.

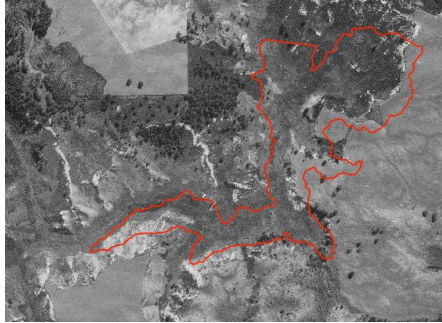
Photograph date (source)	Activities	Aerial image
1957 Retrolens	The footprint is within a broad gully feature, vegetated with scrub. No anthropogenic development is visible.

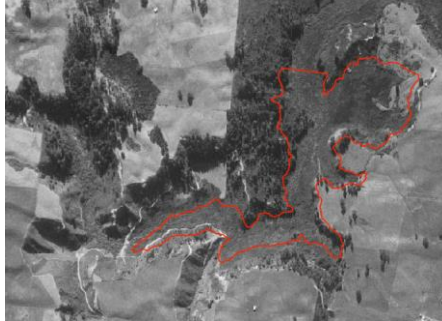
1966 Retrolens	No changes are visible between the 1957 and 1966 imagery.

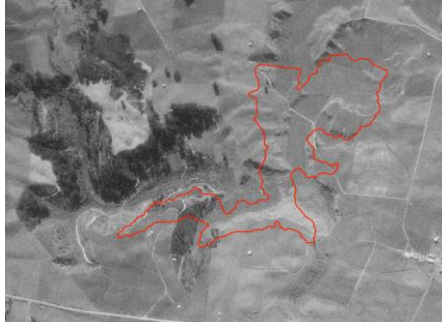
1996 Retrolens	Roading has been established within and to the south and west of the reservoir footprint, vegetation cleared, with pasture and associated fencing established.

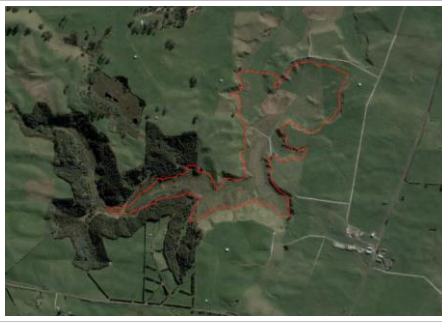
2004 and 2012 Google Earth	Vegetation/ trees have been established adjacent to the western reaches of the reservoir footprint. No changes are apparent between the 2004 and 2012 imagery. The imagery is from 2004.

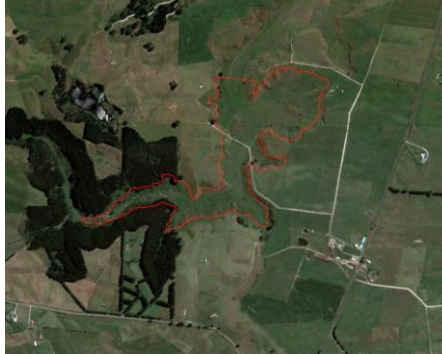
2016 Google Earth	No major changes are visible from the 2012 imagery. A small rectangular pond is visible in the westernmost part of the footprint.
