Appendix I. Contaminated Land Review

Te Tai Tokerau Water Trust
Whangarei

14 September 2020

Te Ruaotehauhau Water Storage Reservoir, Kaikohe – Ground Contamination Review

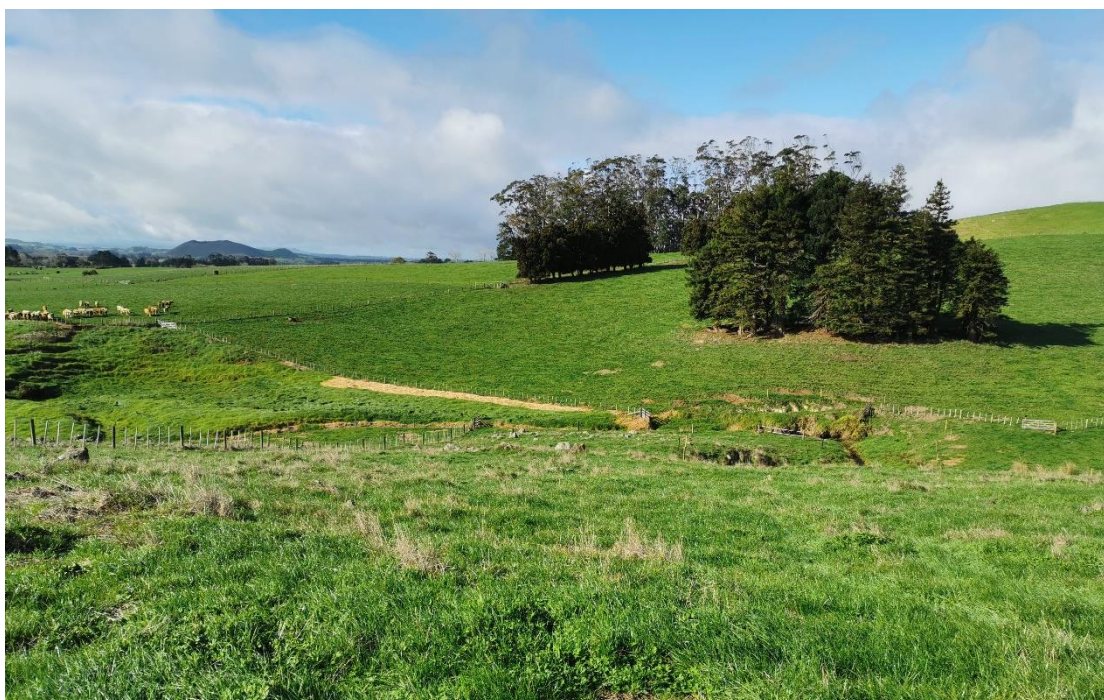
The site walkover confirmed the most recent aerial imagery review (Google Earth, 2020) with fencing present and no roadways or other structures identified. Use of herbicides was observed (strips of dead vegetation) along fence lines.

Photograph 1. Current features within the Te Ruaotehauhau Water Storage Reservoir footprint.

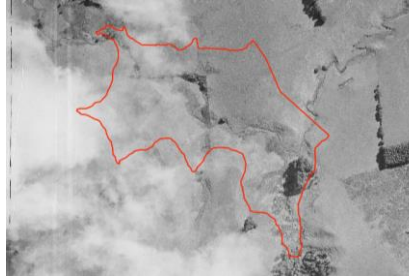
Photograph date (source)	Activities	Aerial image
1955 Retrolens	The footprint is partially obscured by cloud in the western side. The land appears undeveloped bare pastoral. A watercourse runs from the northwest to the southeast corner and is vegetated in patches with shrubs and large trees in the west. Potential slope instability visible in the central east of the site directly north of the large trees.

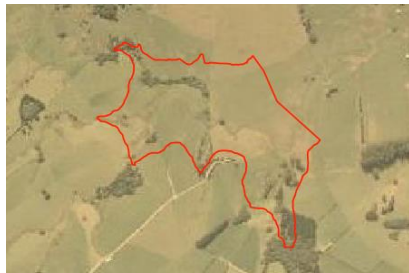
2000 Far North District Council Geomaps	Roading has been extended approaching the centre of the footprint. No changes are apparent within the footprint.

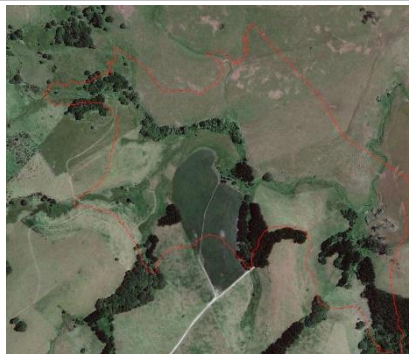
2009 Google Earth	New roading tracks can be seen leading into the northwest corner. Extensive planting or irrigating has been undertaken in the central segment of the site. A narrow road is present through the segment.
