Appendix H. Archaeological Assessment Report

Archaeological Assessment of the Proposed
Aratapu Water Storage Reservoir
Aratapu

1 September 2020

Te Tai Tokerau Water Trust

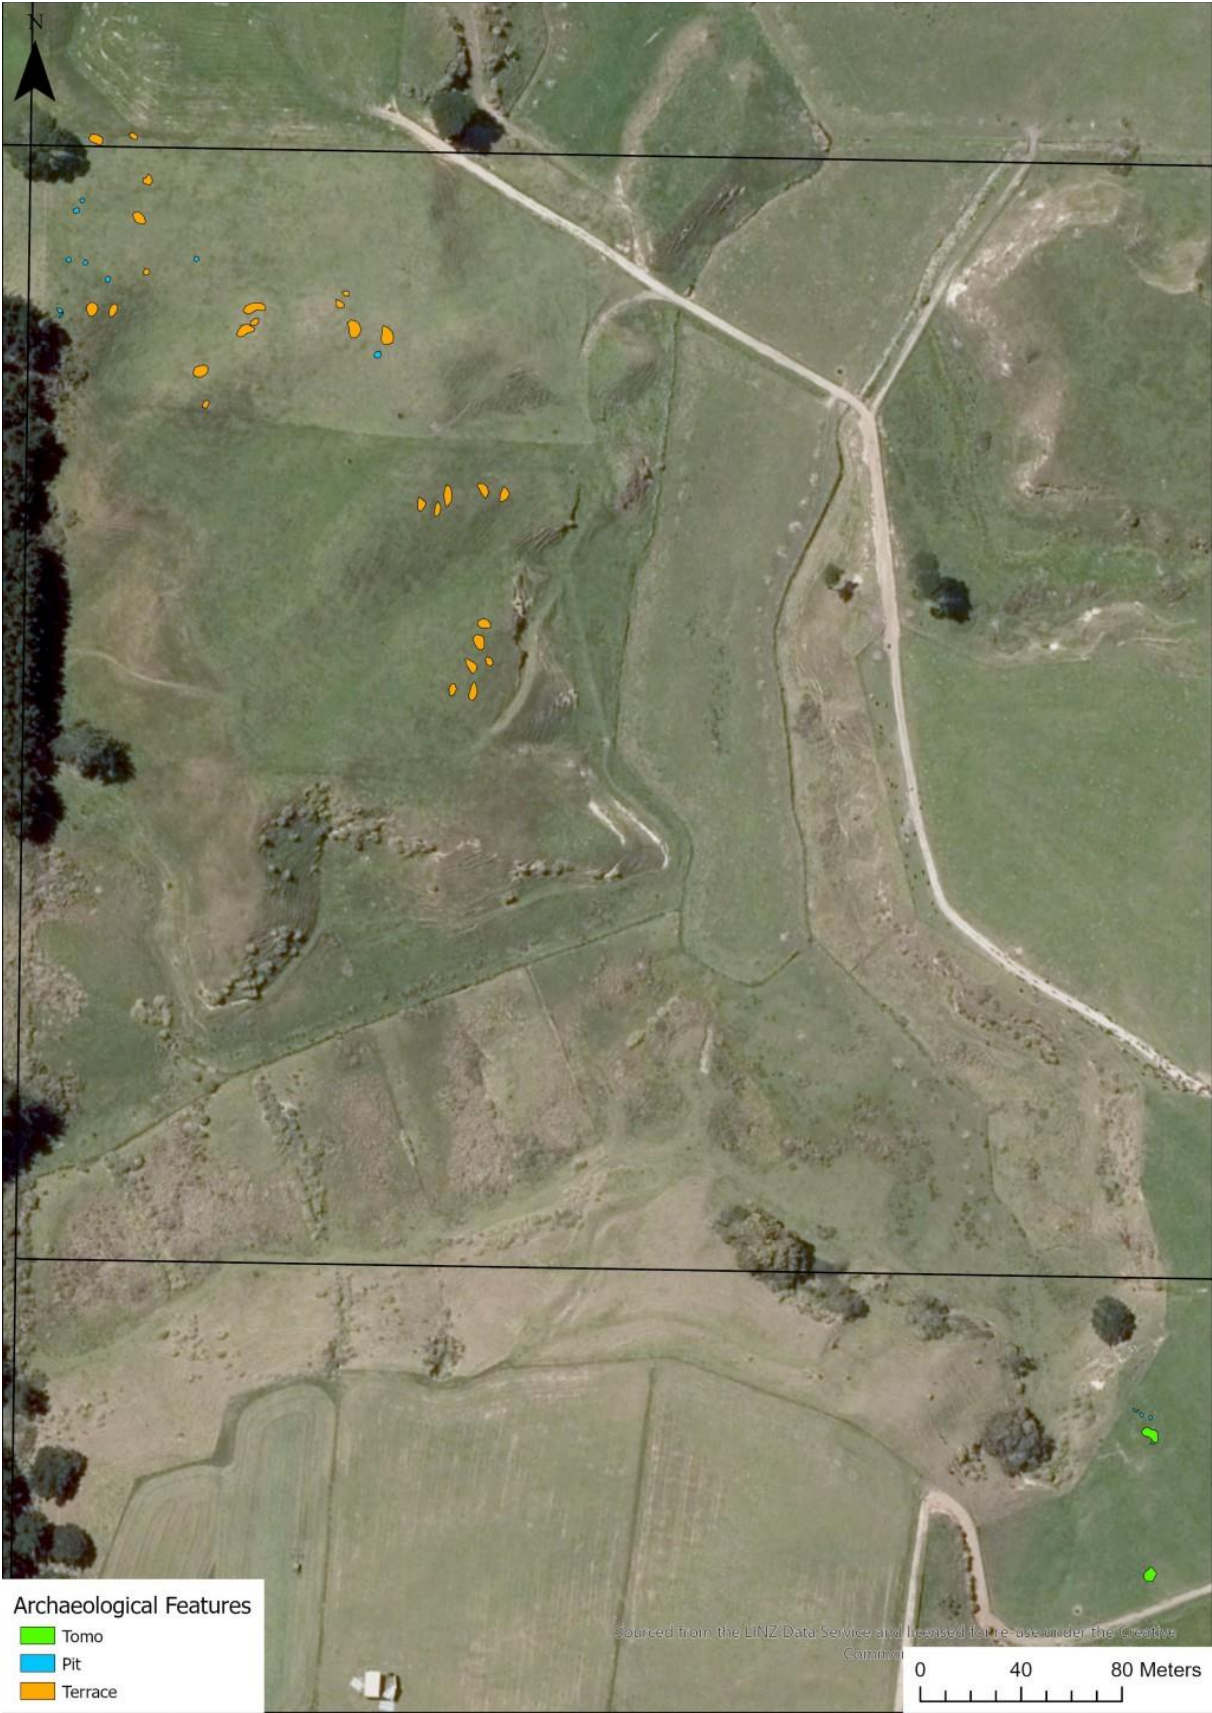
Figure 17: P08/388 Terraces and pits.

Based on the criteria noted above, the site recorded as P08/388 is assessed as being of low to moderate significance.

P08/388 appears to be either a pre-or protohistoric Maori occupation, or potentially a gum digging site based on the form of the features visible on the ground surface, and the land use history of the area. There may be additional subsurface features between the pits and terraces. The observed features are in fair condition.

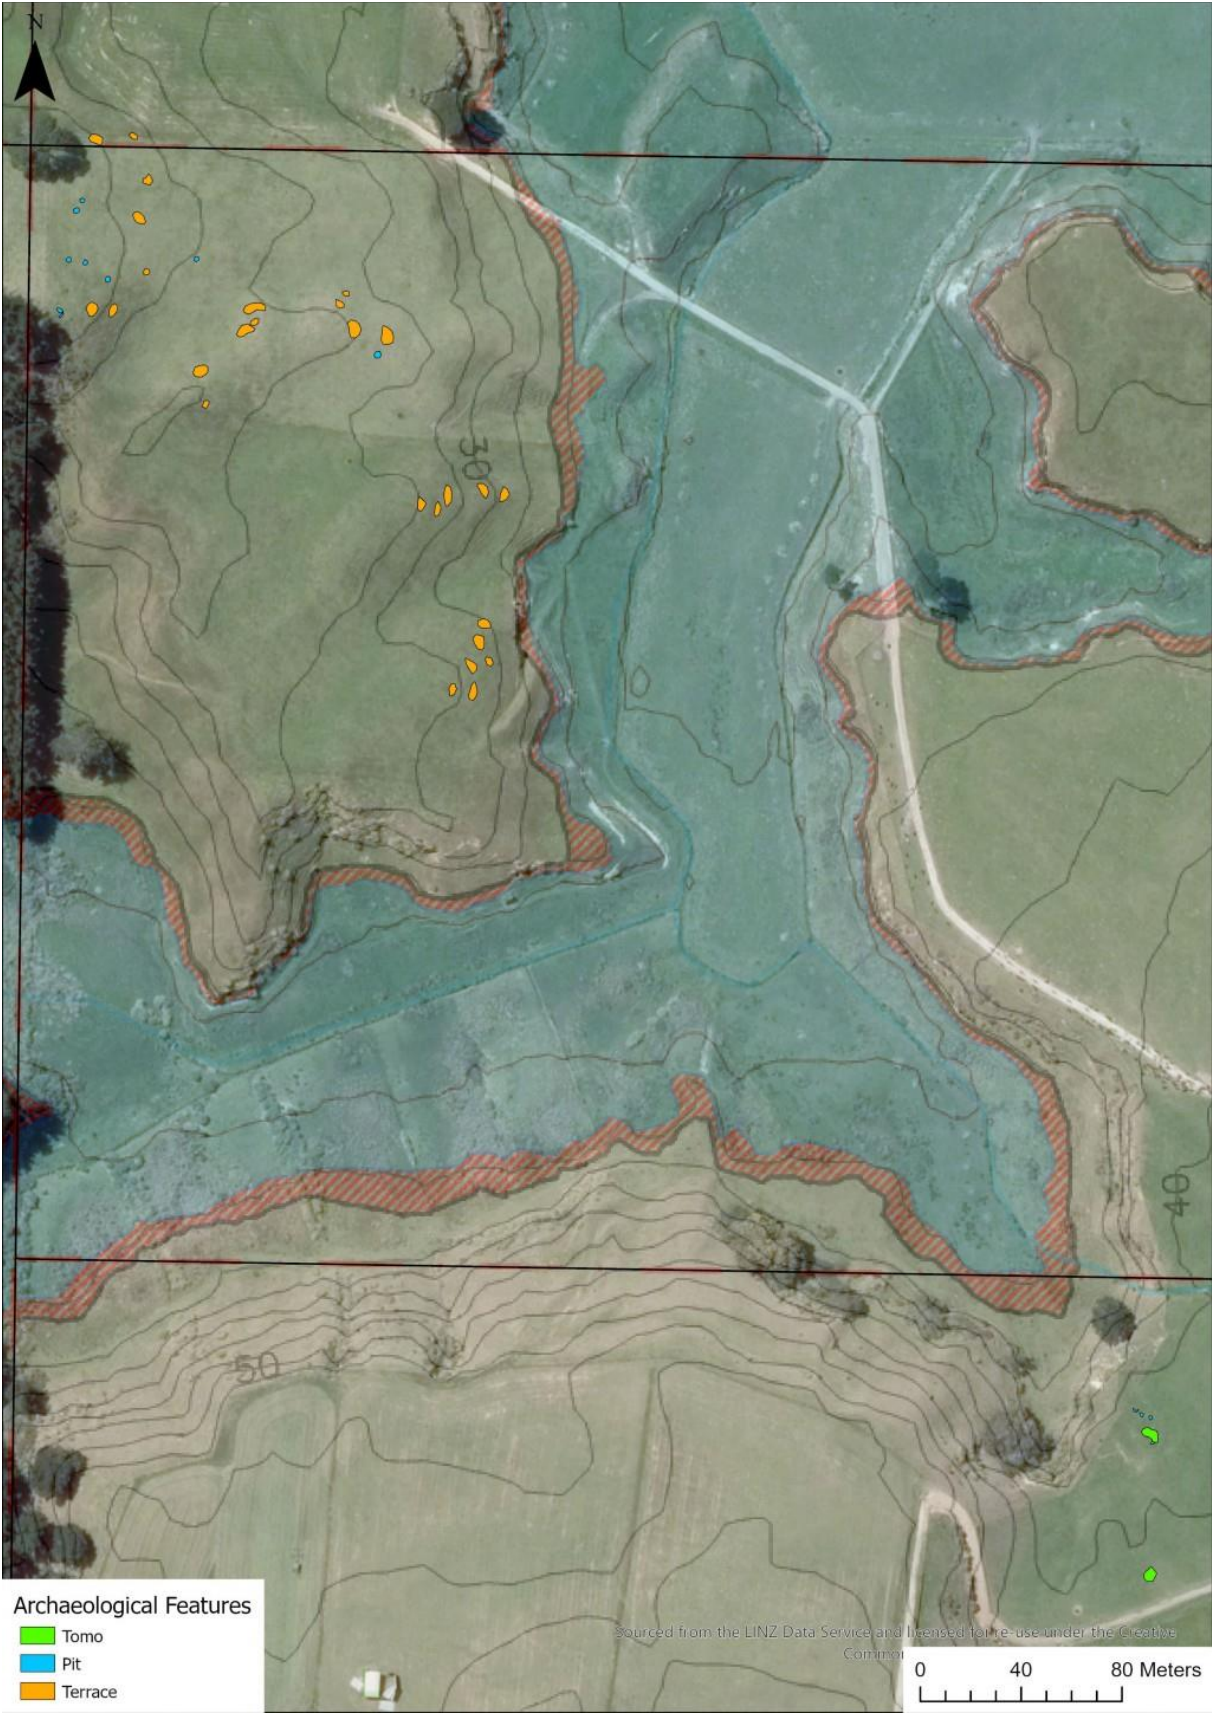
Figure 18: P08/388 Terraces and pits, and inundation levels.

The location of the site is above the proposed inundation level and there is no immediate threat to the site. It is recommended that no earthworks, either cut or fill, be undertaken in the immediate area around the site. If earthworks were deemed essential and required in the immediate area, an authority from Heritage New Zealand would be required.

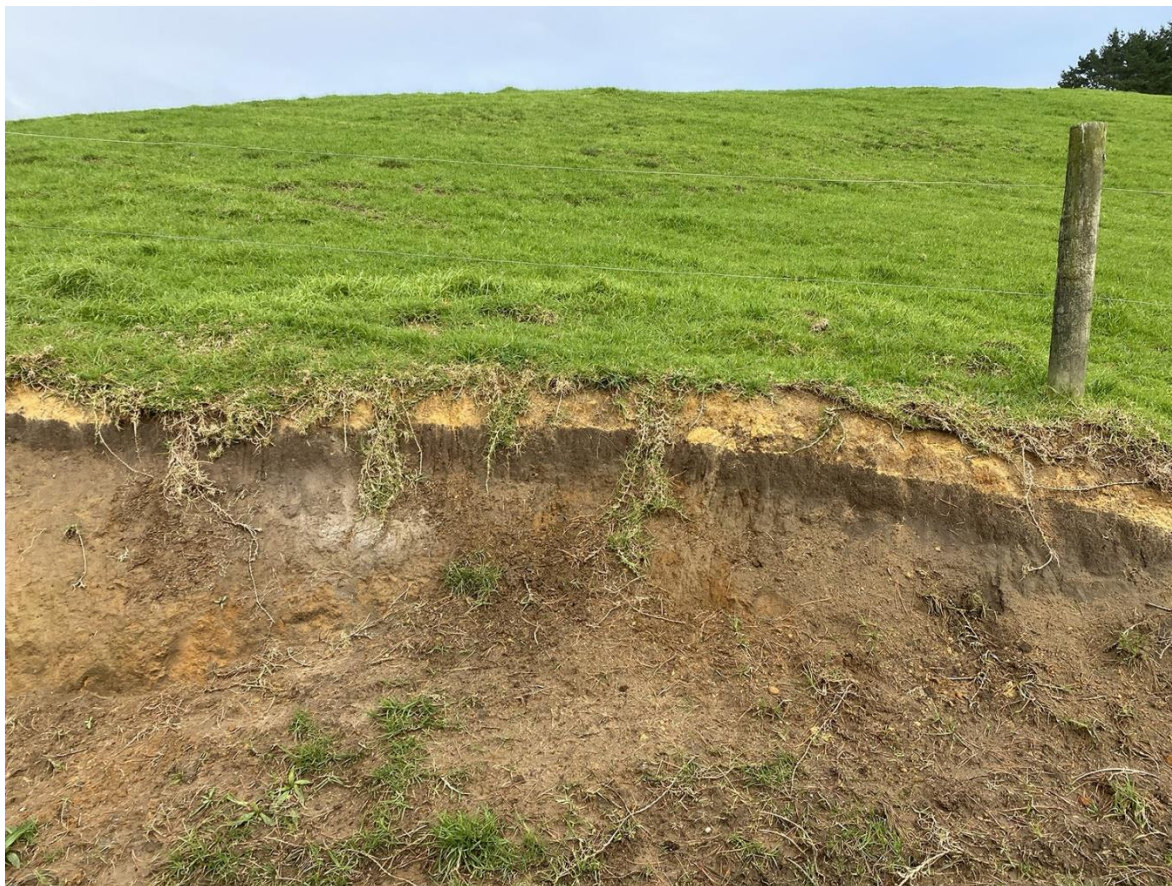
Figure 20: Typical soil profile in the project area.
