Archaeological Assessment of the Proposed
Te Ruaotehauhau Water Storage Reservoir
Ohaeawai

1 September 2020

Te Tai Tokerau Water Trust

Geometria Limited
PO Box 1972
Whangarei 0140

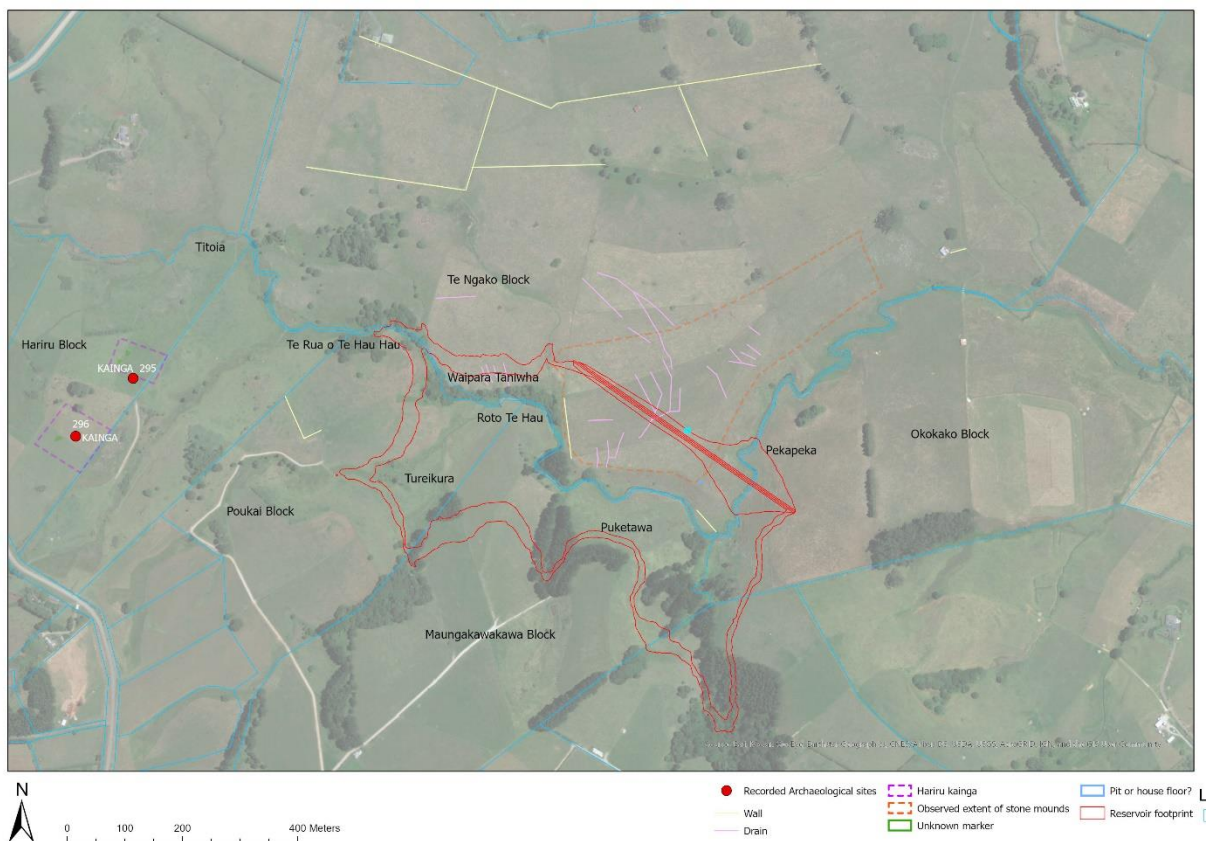
A number of archaeological sites and features or other features of historic or cultural interest were observed across the project areas and adjacent to the reservoir. These include dry stacked stone field boundary walls, low stone mounds associated with pre- or protohistoric Maori horticulture, possible pit or house floors, obsidian flakes, and taro.

Figure 20: Archaeological, historic and cultural features at Te Ruaotehauhau reservoir.

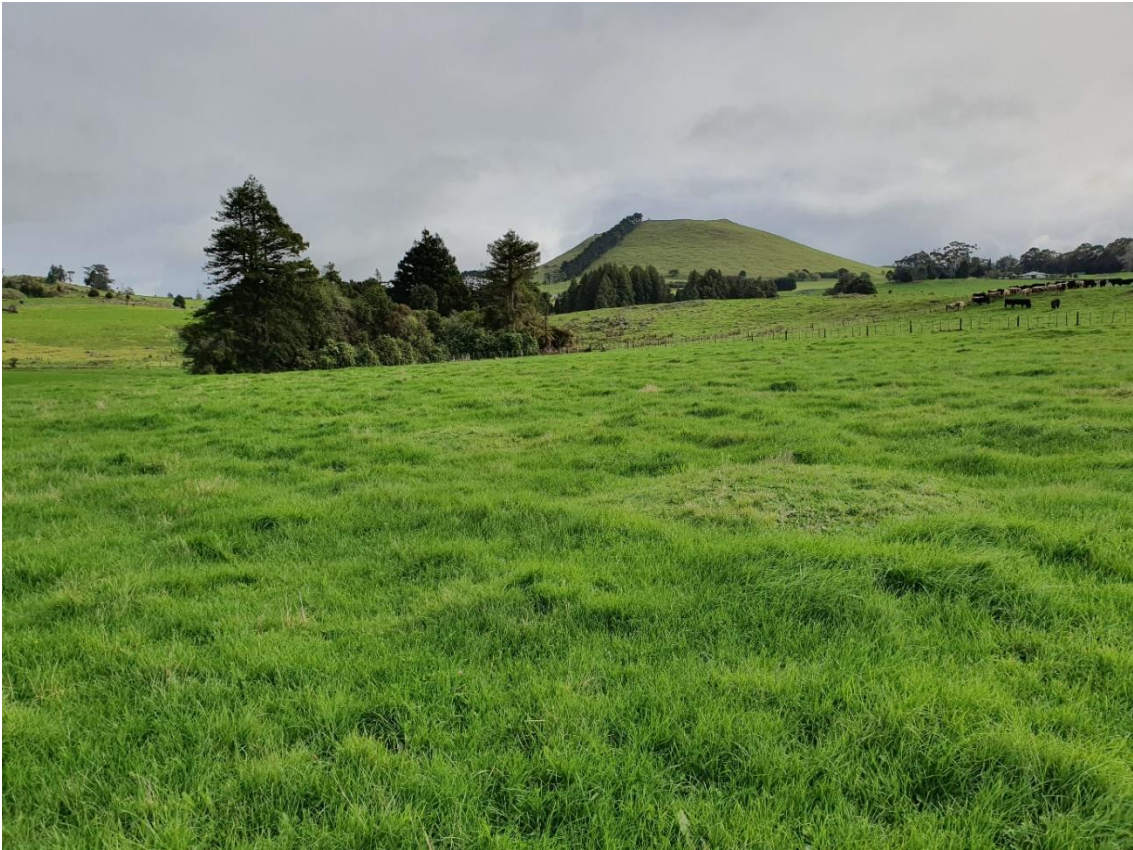
Features consisted with pre- or proto-historic Maori horticultural activities were observed on the northern/eastern side of the stream, on the Dixon property. These features comprised stone and earth mounds. The mounds were observed on the flat to gently sloping ground approximately 5-10m above the stream.

The mounds are typically circular with diameters of 1.2-1.4m, spaced at intervals of 7-10m. The internal arrangement of several mounts was visible due to stock damage, the mounds comprising an outer ring of larger volcanic rocks with an inner core of smaller stones and soil. The area of observed stone gardening mounds covered an area of approximately 10ha.

Figure 21: Maori horticultural system; looking north to Te Ahuahu over stone mounds.

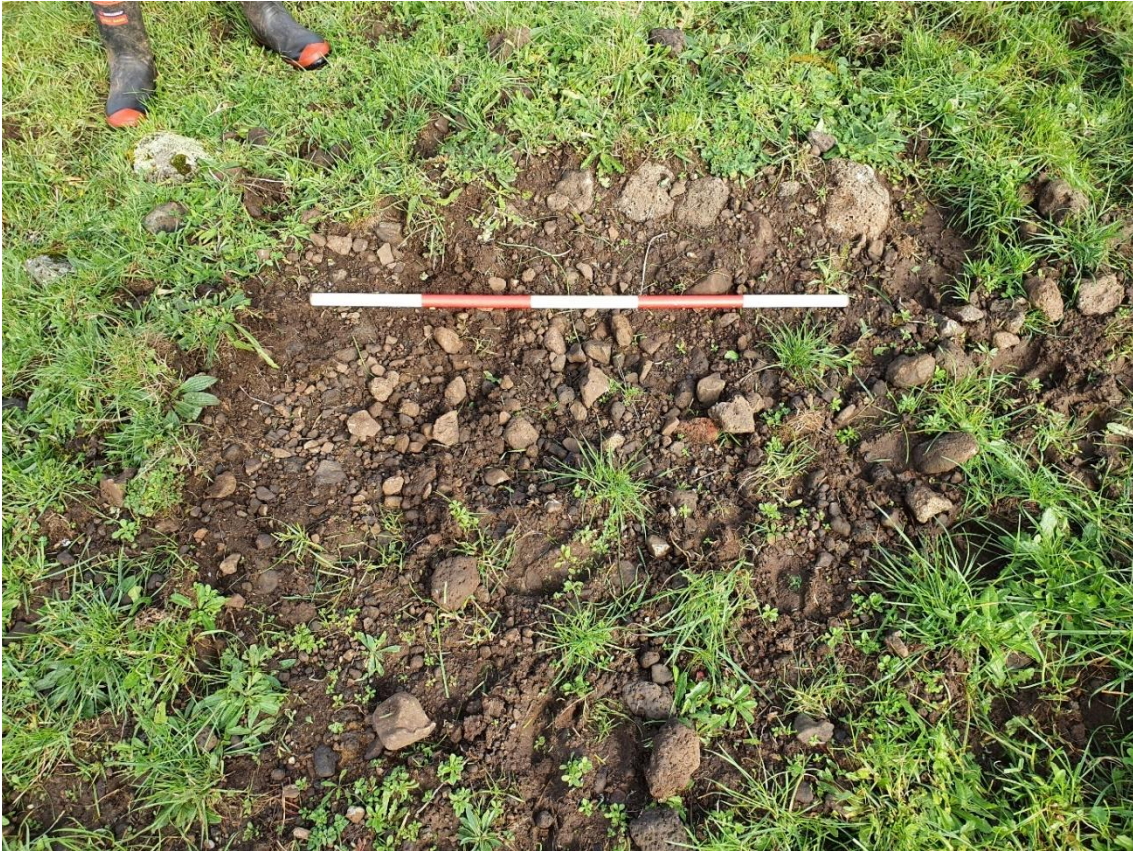
Figure 22: Stock-trampled stone mounds after severe flooding.

The system is largely intact, except for minor damage from stock, farm fencing and track making, and possibly from robbing rock for later historic/modern stone wall construction.

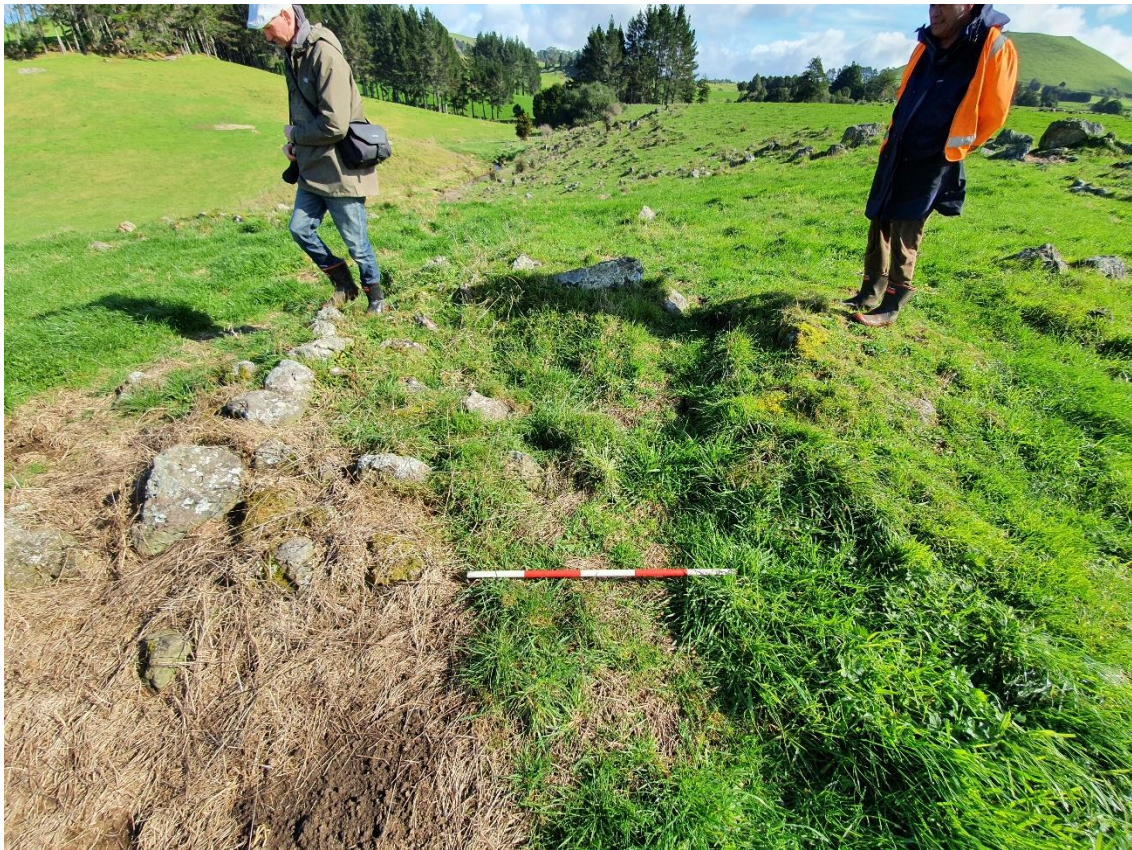
Two possible pits or house floors were observed just off the level ground, on the bouldery tongue of land above the confluence of the main stream and the gully to the south. These features comprised approximately rectangular, stone-free areas.

Figure 23: Possible stone lined pit or house floor.

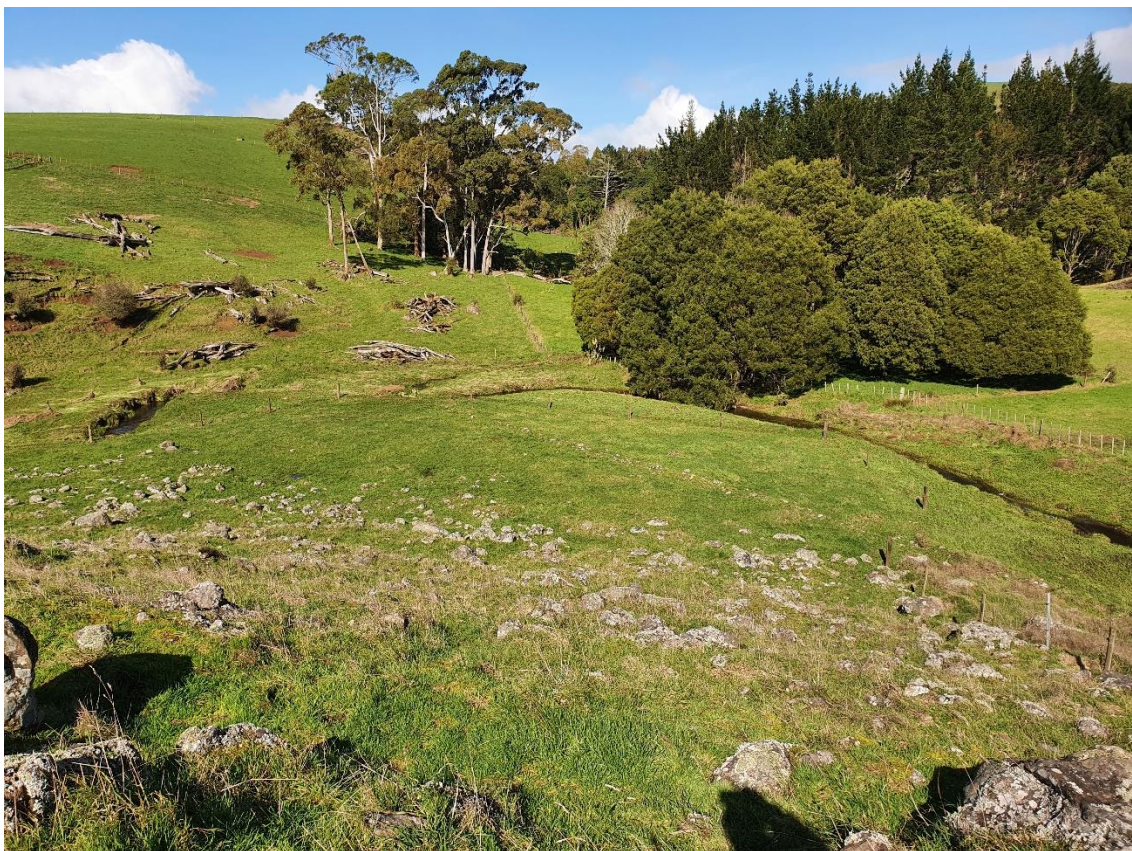
In the course of the first visit, the presence of stacked dry-stone farm walls was noted on the Dixon property. These included intact/serviceable stone walls outside the project area on the Dixon property, and to the west on the Bell property, typically 1.6m high and 1.2m wide at the base. Two sections of largely destroyed stone wall, consisting of a single course of volcanic rock approximately 80cm wide and 40cm high were observed immediately east of the stream, on level to gently sloping ground, on the Dixon property. These features are within the inundation zone.

Figure 24: Southern stacked dry stone wall remnant.

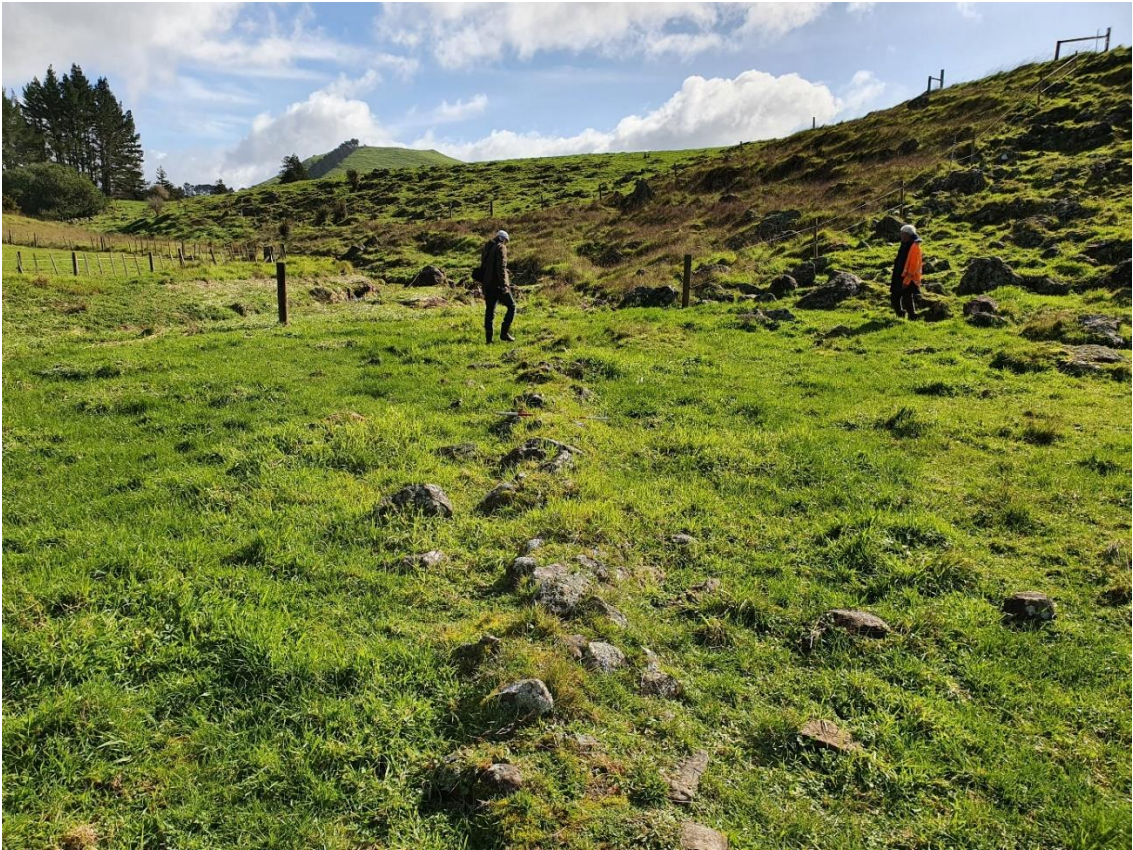
Figure 25: Detail of stacked dry stone wall remnant.

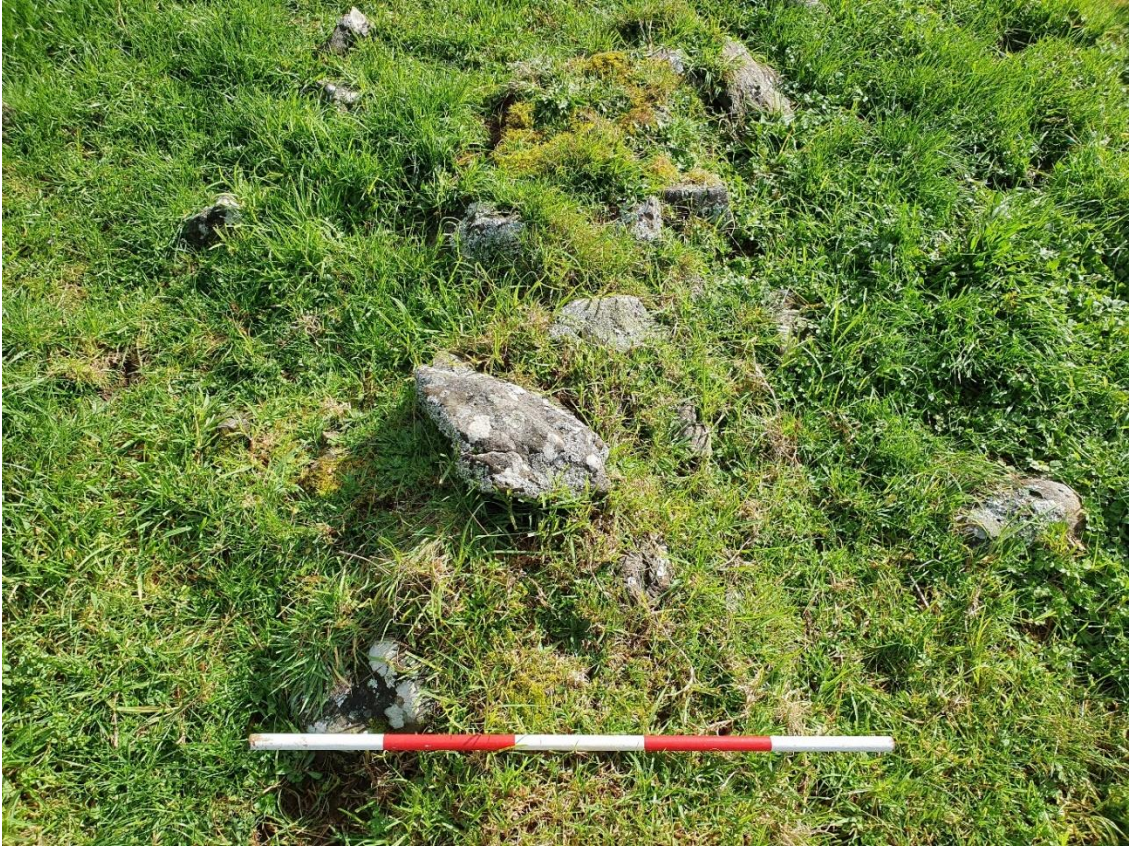
Figure 26: Detail of stacked dry stone wall remnant.

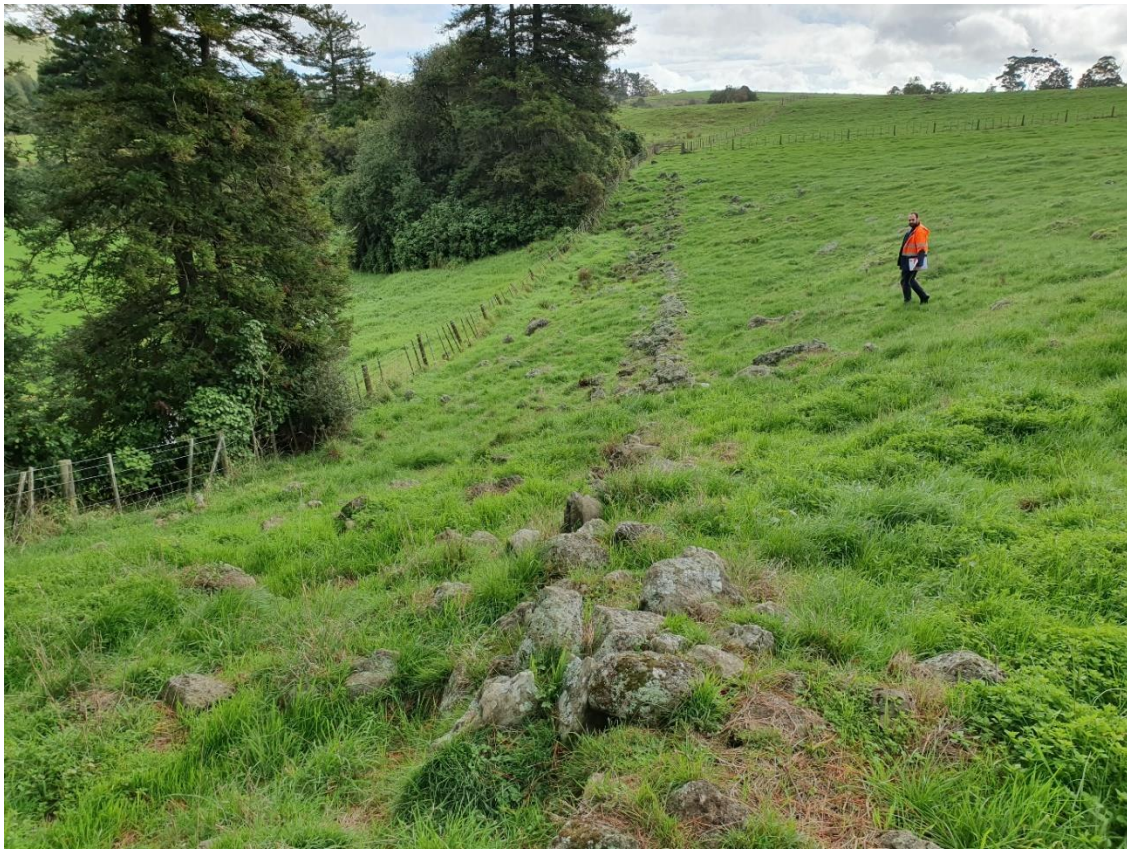
Figure 27: Northern stacked dry stone wall remnant.

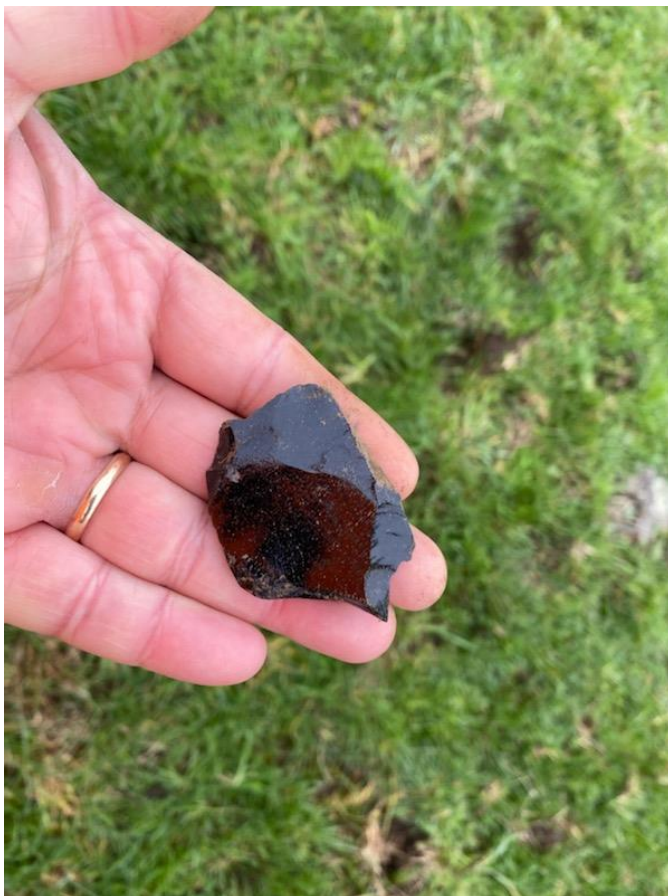
A large obsidian flake was recovered from the stream flats near the southern section of stone wall. The flake has a small amount of cortex on one side, suggesting primary reduction was occurring in the area. It is possible that the flake has washed down from further up the stream, but regardless of its ultimate origin on the stream it is suggestive of stone tool production nearby.

Figure 28: Obsidian flake from stream flats.
