# **GEOTECHNICAL AND SITE SUITABILITY ASSESSMENT**

## **TE RUAOTEHAUHAU WATER STORAGE RESERVOIR, OHAEWAI**

**Report reference:** 200240-E

**Date:** 1 September 2020

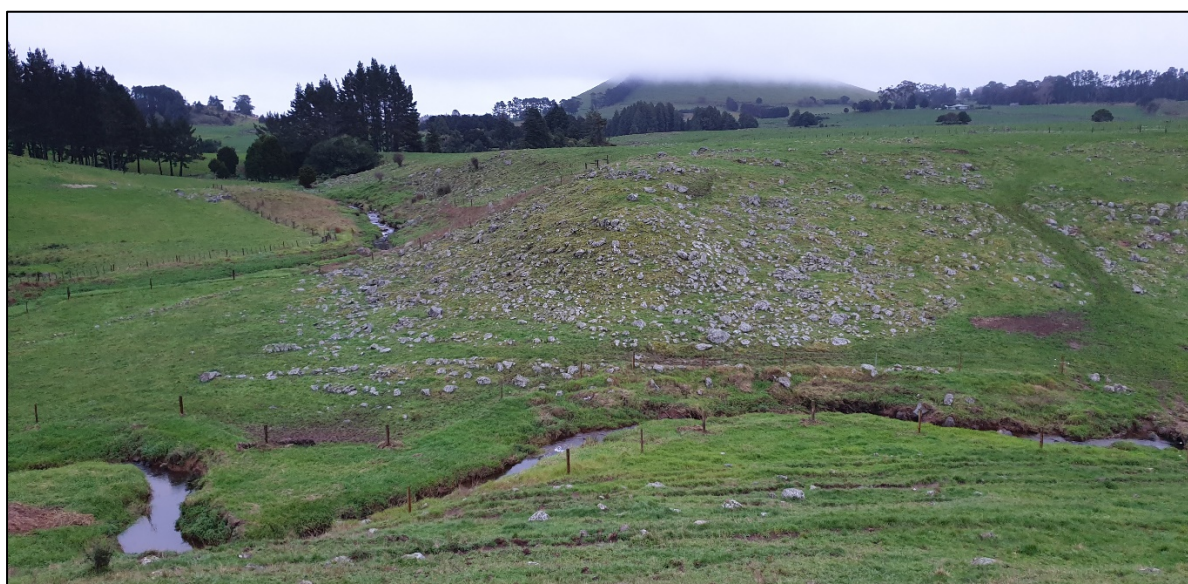
**Figure 1: View west from right abutment along main dam alignment. Te Ahuahu scoria cone partly obscured by fog in the middle background.**

Topography comprises a generally flat terrace on the left abutment and moderate slopes on the right, each formed by pre-historic lava flows (Figure 1). The catchment is predominantly in pasture, with isolated areas of wetland and forest predominantly along riparian margins.

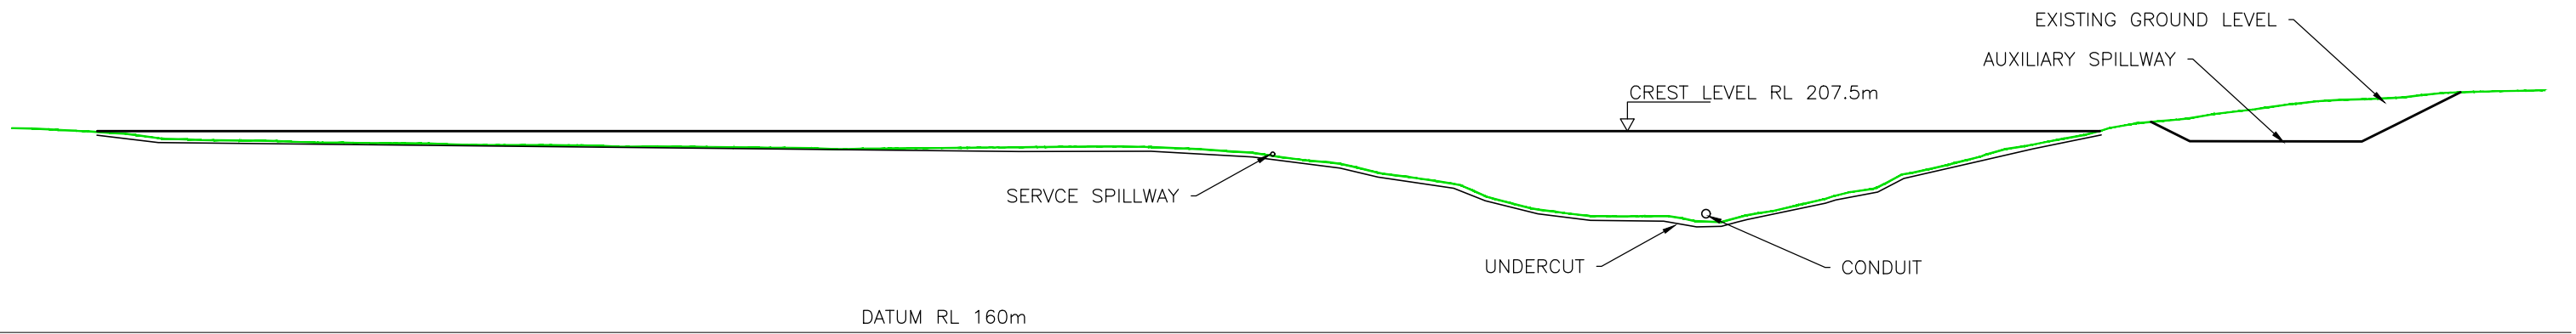
**DAM LONG SECTION @ CENTRELINE**  
SCALE 1:1500

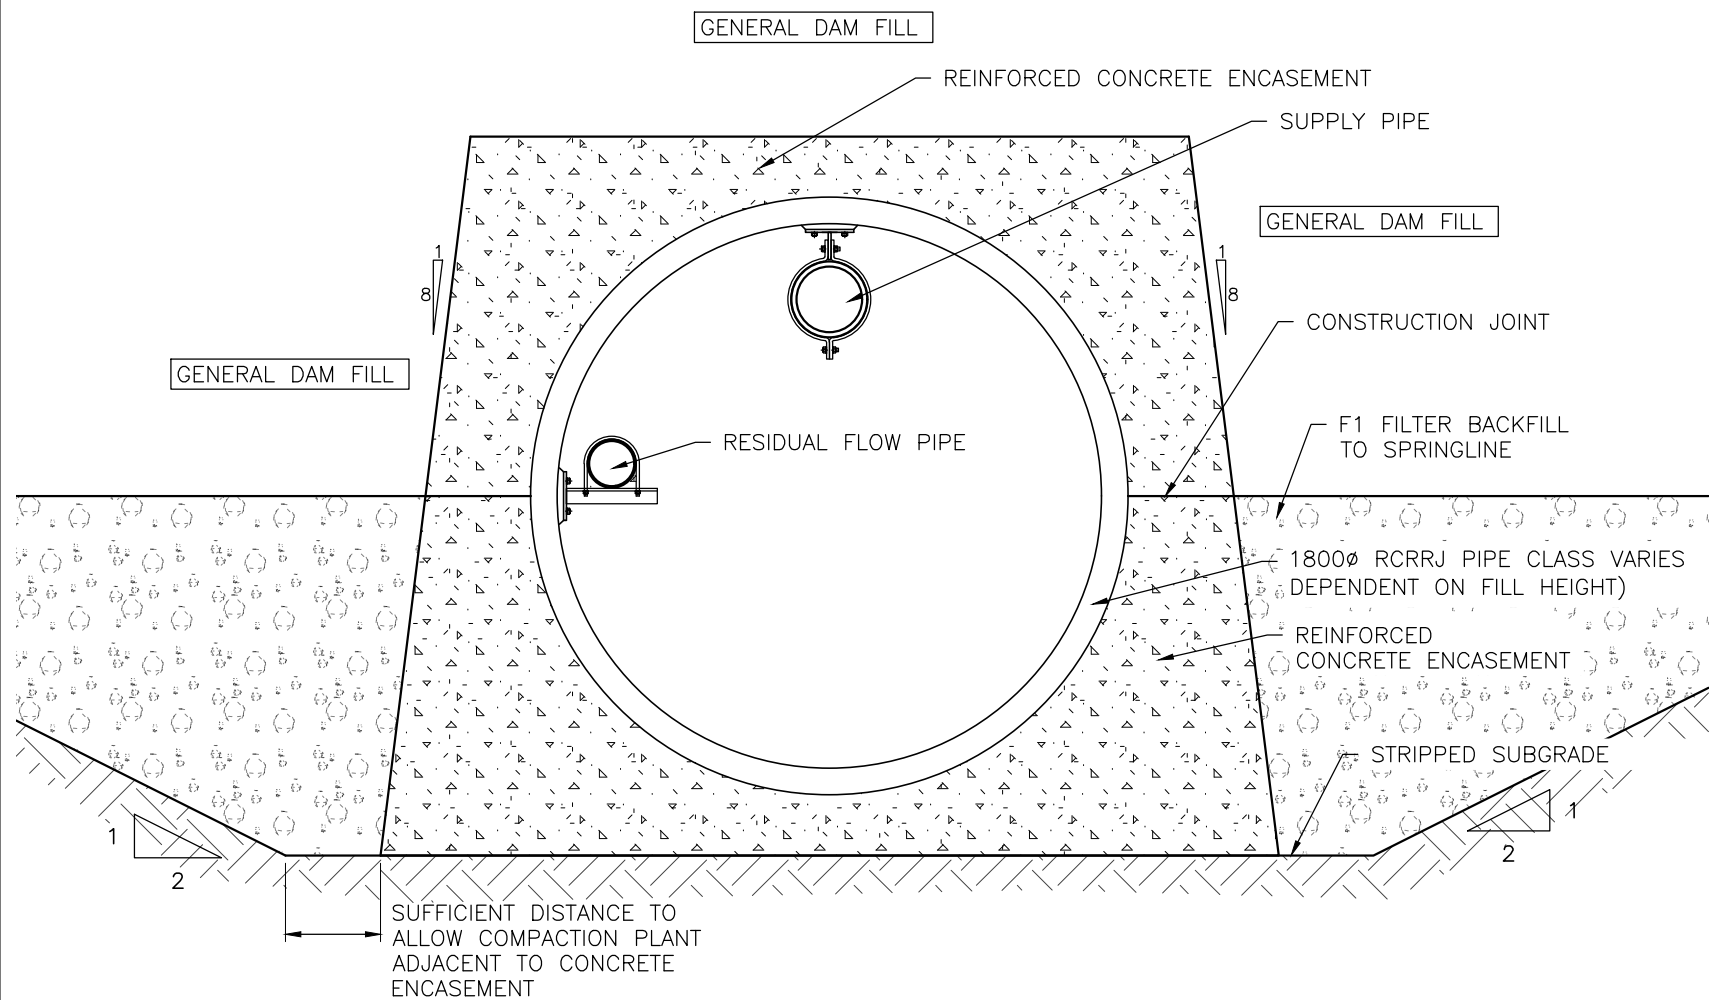
**DETAIL 1 TYPICAL CONDUIT CROSS SECTION**  
SCALE 1:25

A low-level conduit installed within the valley floor at the toe of the left abutment would provide temporary flood diversion during construction, house both a residual flow pipe and supply pipes and provide emergency dewatering facilities. The current concept includes both service/primary and auxiliary spillways. The service spillway could be incorporated into either the left or right abutment; the auxiliary spillway is envisaged to be formed beyond the right abutment, discharging to the stream approximately 200m below the dam. The service spillway could also be incorporated within the auxiliary spillway. Refer to RILEY Dwg: 200240-106.

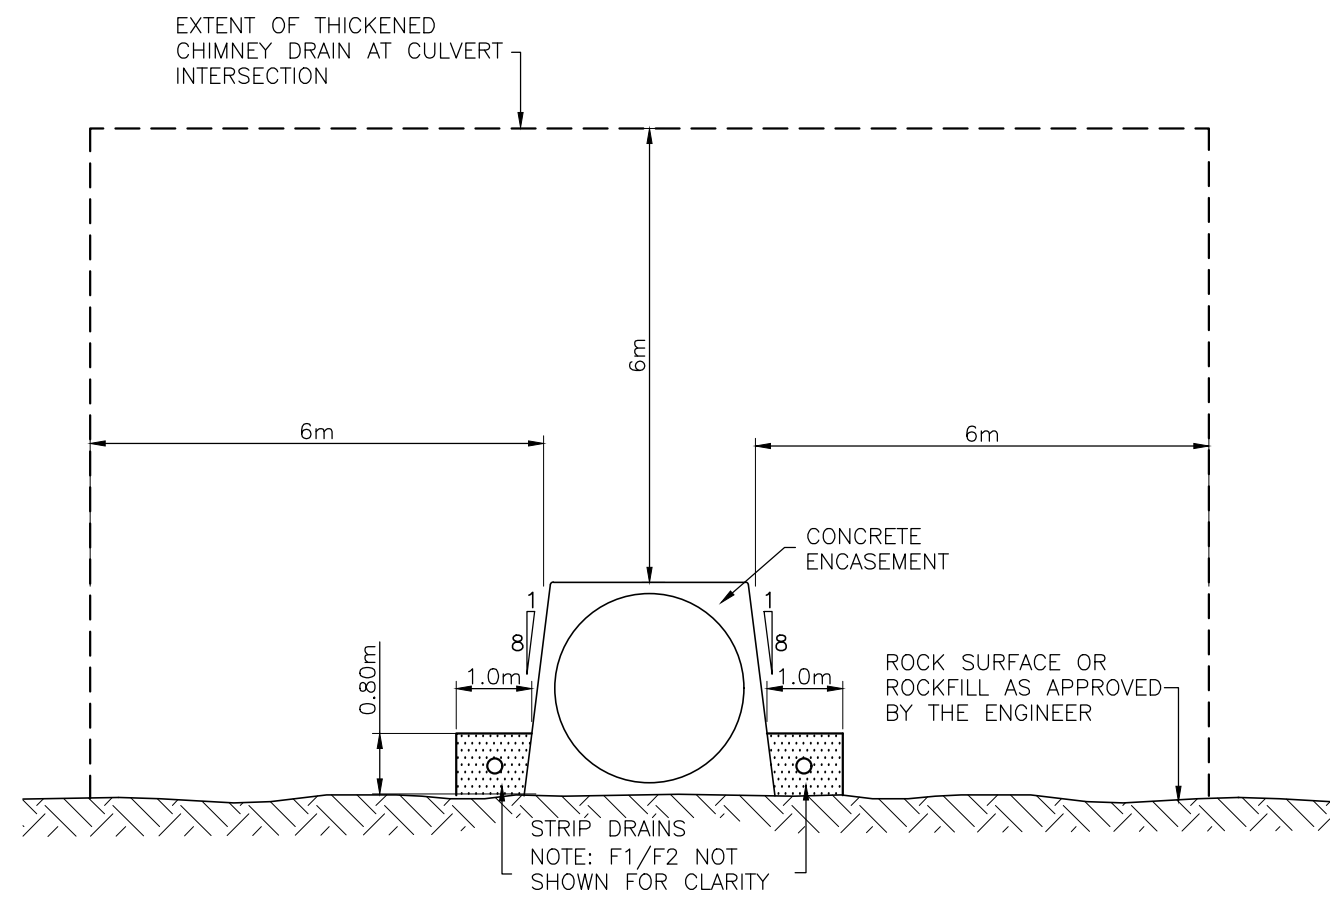
**ELEVATION 1 CHIMNEY DRAIN THICKENING AT CONDUIT**  
SCALE 1:100

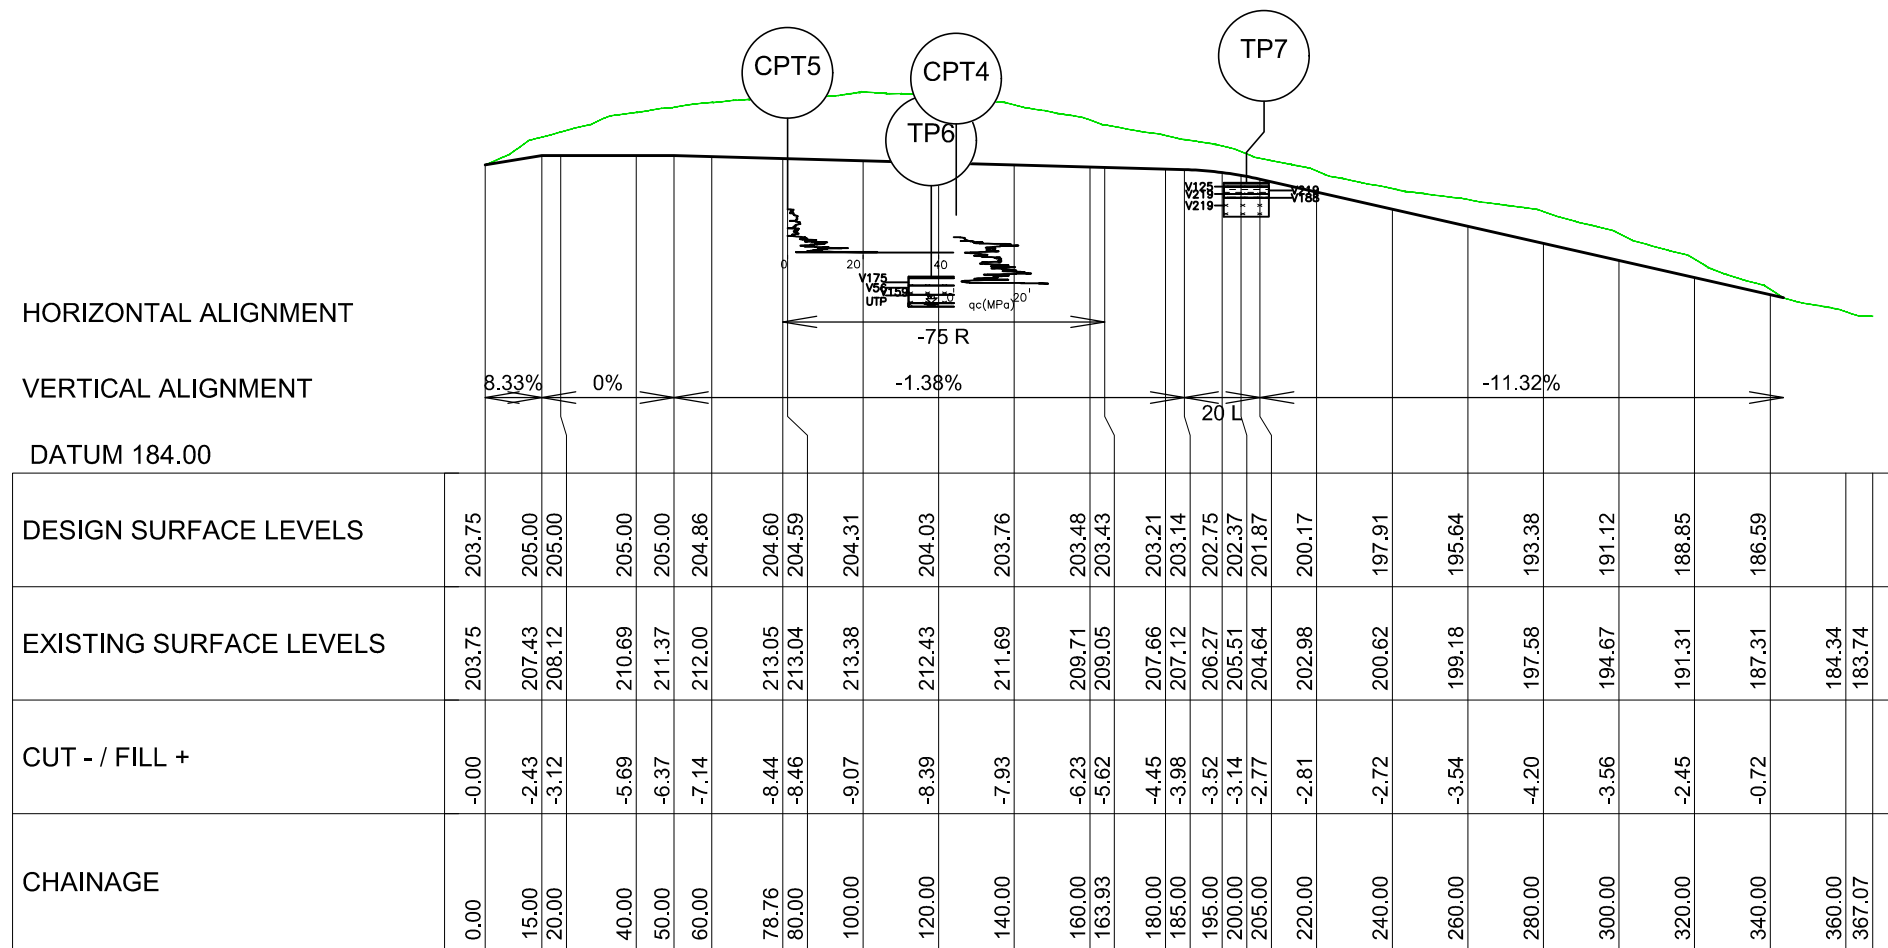
**AUXILIARY SPILLWAY LONG SECTION**  
SCALE 1: 2000 HOR 1:1000 VERT

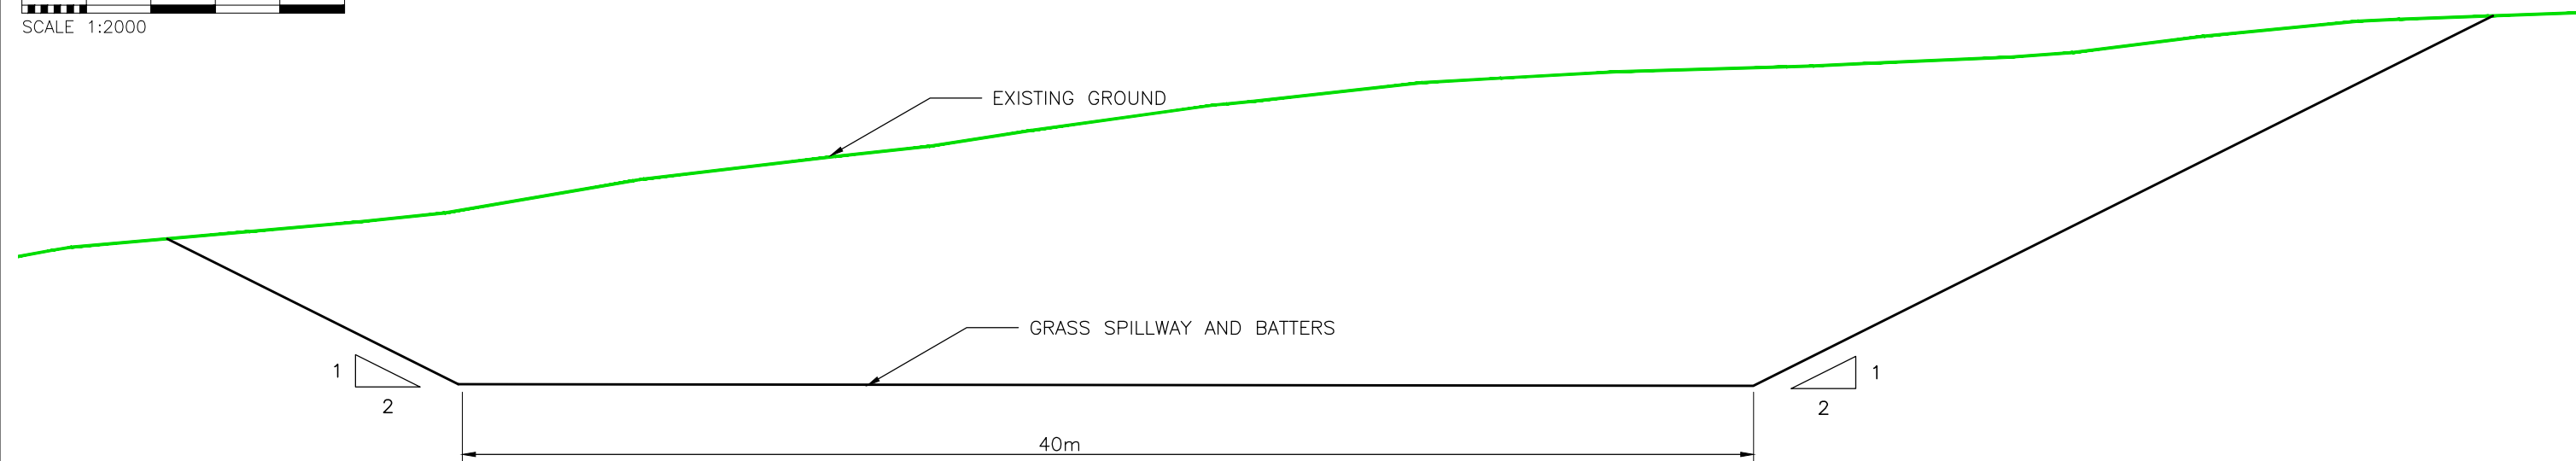
**AUXILIARY SPILLWAY TYPICAL CROSS SECTION**  
SCALE 1: 200
